Manhole Inspection Summary

Manhole # S47CC_059MH

Insp Date: **2/7/08 8:50 AM**

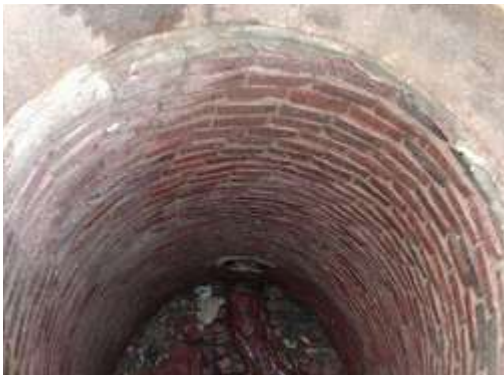
Defect 1

☒ **Leaks**

Frame Leaks

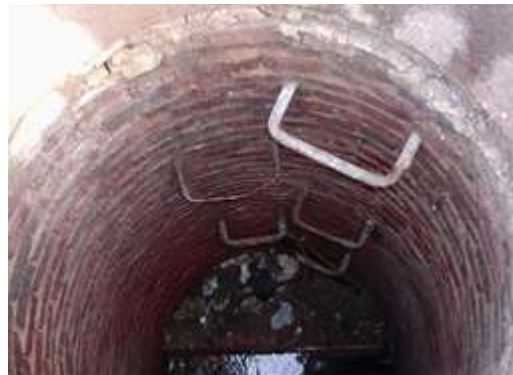
Defect 2

Condition: ☐ Sound ☐ Cracked ☐ Root Intrusion ☒ **Loose Brick** ☒ **Deteriorated**

Infiltration: ☐ None ☐ Joint ☐ Cracks ☒ **Mortar** ☐ Roots ☐ Wall

Deterioration

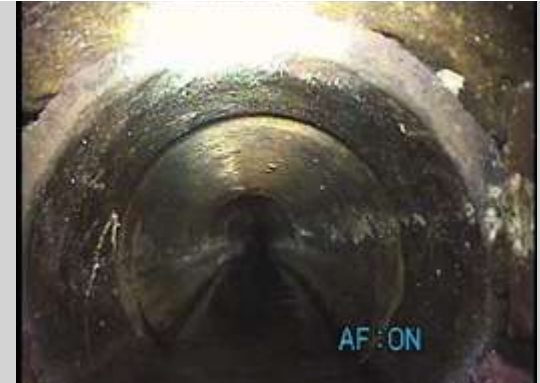
12 O'Clock Outflow

8 in. Circular Gravity Sewer
Pipe Out @ 12 O'Clock

Pipe Height: **8.4** (in.) Rod and Bar (Angled)
Pipe Material: **Clay** ☐ Pipe Lined
Invert Depth: **10.10** (ft.) Flow Characteristics: **Slow**
Deposits: ☒ None ☐ Mud ☐ Sludge ☐ Debris ☐ Grease
Silt Depth: (in.) Deposits Extent:
Infiltration: **None** Pipe Seal Cond: **Sound**

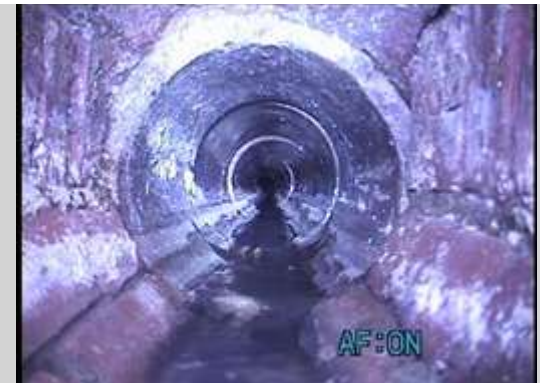
6 O'Clock Inflow

8 in. Circular Gravity Sewer
Pipe In @ 6 O'Clock

Pipe Height: **8.4** (in.) Rod and Bar (Angled)
Pipe Material: **Clay** ☐ Pipe Lined
Invert Depth: **10.00** (ft.) Flow Characteristics: **None**
Deposits: ☒ None ☐ Mud ☐ Sludge ☐ Debris ☐ Grease
Silt Depth: (in.) Deposits Extent:
Infiltration: **None** Pipe Seal Cond: **Sound**

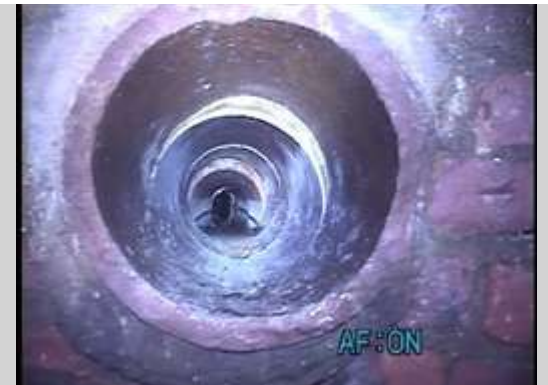
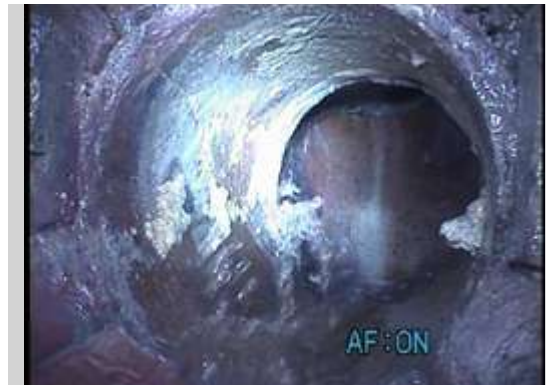
9 O'Clock Inflow

Pipe In @ 9 O'Clock

Drop In @ 9 O'Clock

Drop: **Outside** Rod and Bar

Drop Condition: **Open**
